iqmaxrefdes23 Documentation

IQ2 Development GmbH

Maxim's Santa Cruz (MAXREFDES23#) reference design is the world's smallest IO-Link® light sensor compliant with IEC 61131-9. The entire design fits onto a 6.5mm x 25mm printed circuit board (PCB).

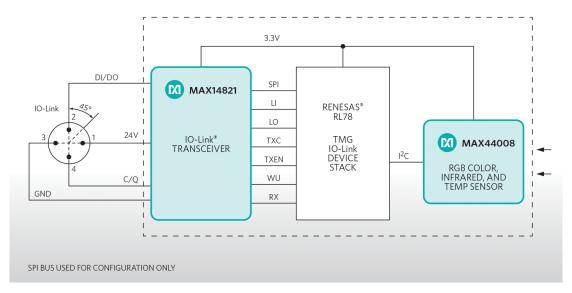
The purpose of this project is by giving the user a strong basis to start develop production-ready IO-Link® application based on Maxim Integrated IO-Link device transceiver (MAX14821), a Renesas ultra-low-power, 16-bit microcontroller (RL78) and iqStack® IO-Link Device Stack.
